TITLE: The Inadequacy of Safe-Life Prediction: Aero-Engine Fan and Compressor Disk Cracking

## **The Inadequacy of Safe-Life Prediction: Aero-Engine Fan and Compressor Disk Cracking**

**B.J. Wicks, R.A. Antoniou, S.L. Slater and J. Hou**

Aeronautical and Maritime Research Laboratory

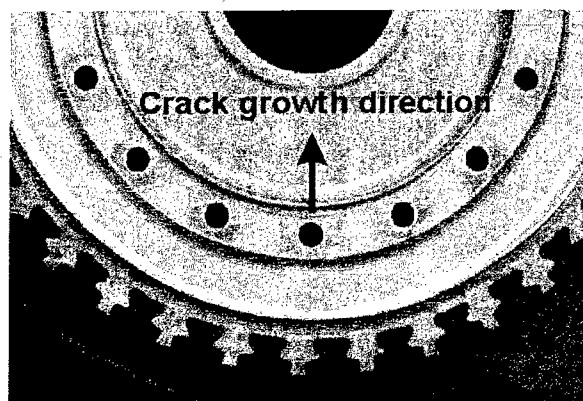
Figure 1: Disk geometry and crack growth direction.

Following the detection of a crack emanating from a bolt-hole in an engine disk, an investigation was undertaken to determine the subsequent crack growth behaviour. The disk geometry and observed crack direction are shown in Figure 1. The radial crack emanating from the bolt-hole was cut from the disk and opened, revealing the crack face shown in Figure. 2. The cracking was found to be due to fatigue which had started within the bore of the hole and away from the corner. The crack markings were examined using both optical and scanning microscopy and the crack growth rate was predicted using both numerical and analytical methods and compared to the measured growth rate.

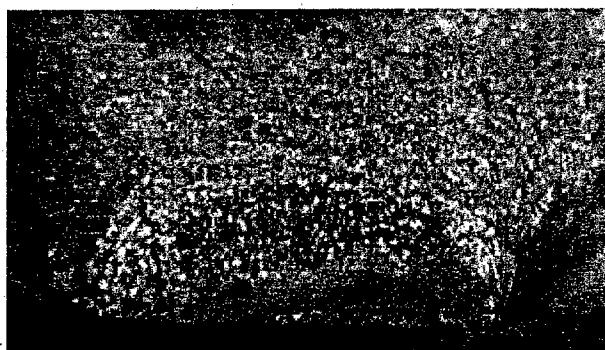
Figure 2: Radial bolt-hole crack using optical microscopy.

The metallographic studies indicated the presence of a surface deformed layer, with a depth of approximately 0.6 mm, and the crack growth progression measurements on the fracture surface showed rapid crack growth through the deformed layer from multiple surface cracks all around perimeter of the hole. Furthermore the presence of tungsten carbide was detected at the surface, presumably from a piece of tooling.

The fatigue cracks originated in alpha case particles in the microstructure of the hole surface, indicative of localised overheating. It was concluded from these observations that an abusive hole drilling or reaming operation caused overheating and localised damage.

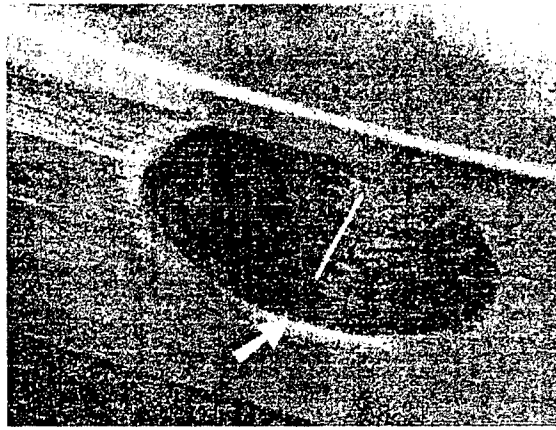
Figure 5. Indication of the crack direction in the bolt hole

A crack was found in the tie-rod hole of a second stage compressor disk. No other cracks of this type had been seen previously. This hole was believed to experience relatively low stresses, and hence was not expected to be life-limiting in terms of low cycle fatigue. An indication of the orientation of the crack is shown in Figure 5.

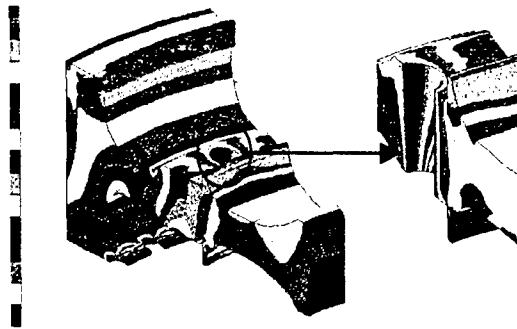
Figure 4: Maximum principal stress distribution for the disk with detailed view of the critical location.

A 3D FE sub-model (22.5° sector), including all the local geometry features, was created for the disk. The solutions from the 3D FE assembly model were transferred to the cutting boundaries in the sub-model and the stress distribution of the disk were determined, as shown in Figure. 4. The maximum principle stress of 435 MPa occurs under maximum power settings at the bore-side of the bolt-hole, indicating the region where a crack is most likely to form, and in fact where it was observed.

Furthermore, from fractographic analysis it was determined that crack propagation rates through the deformed microstructure were twice as fast as through the non deformed microstructures, with the cracks perpendicular to the maximum principal stress becoming propagating cracks. The crack growth analyses carried out as part of the FE analysis corresponded very closely with the fractographic measurements, indicating that failure of the disk was likely within the scheduled safe life.

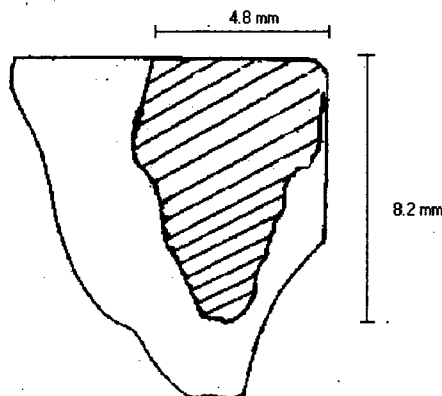
Figure 6. Schematic of the shape of the crack

The single longitudinal crack on the inner surface of the tie rod hole showed extremely faint markings consistent with fatigue progression marks. The crack was very deep with a short surface length and is shown schematically in Figure 6. The material of the disk and adjacent components was Ti-8Al-1Mo-1V.

The crack was difficult to observe visually as it did not extend to the outer edge of the hole, appearing to start about 0.8 mm inside the bore of the hole from the front face of the disk.

The crack was noted to be very deep and narrow in relation to its length on the bore surface with a length of about 4.8 mm and a depth of about 8.2 mm.

The microstructure of this disk was found to contain significant banding of the  $\alpha$  phase. This was probably due to incorrect processing or perhaps segregation in the original ingot. This microstructure has been described previously for this alloy (4)

The crack initiated within the hole at a location coincident with the maximum principal stress ( $\sigma_{hoop}$ ). The propagation behaviour of the crack was determined by the presence of  $\alpha$ -phase bands which tended to constrain the crack growth in the through-disk direction, as a result of preferential crack growth along the  $\alpha$ -bands compared to growth in the normal titanium  $\alpha + (\alpha + \beta)$  microstructure (5).

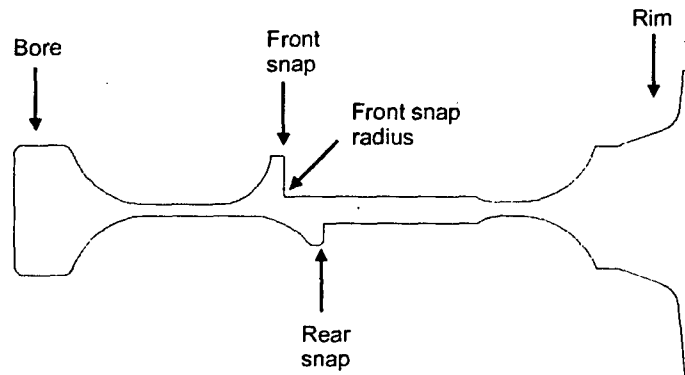
Figure 7: Schematic cross-section of a compressor disk.

A finite element (FE) method was utilised to analyse the mechanical and thermal stress in a 4<sup>th</sup> stage Low Pressure Compressor (4th LPC) disk assembly in an aircraft gas turbine engine(6). This FE analysis indicated that the critical region for fatigue is at a front snap radius. The geometry of the disk is shown in Figure 7.

It was found that the maximum principal stress at the front snap radius dropped rapidly from 800 MPa at the free surface to 350 MPa at a depth of 0.5 mm.

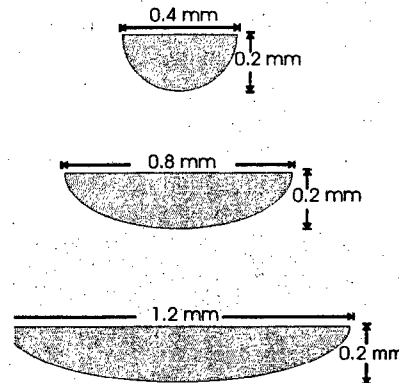
Figure 8 Initial crack profiles used in the analysis

Semi-circular and semi-elliptical surface cracks with a depth of 0.2 mm were inserted perpendicular to the front snap radius at the peak stress location, 25 degrees from the radius

runout (Figure 8). Stress intensity factors (SIF's) were then calculated using the J-integral method. The SIF values at the both free surface ends increase with crack length whilst the crack depth remains constant (Figure 9). Therefore, a crack initiated at the front snap radius is expected to grow preferentially in the circumferential direction and to grow at a slower rate in the radial direction.

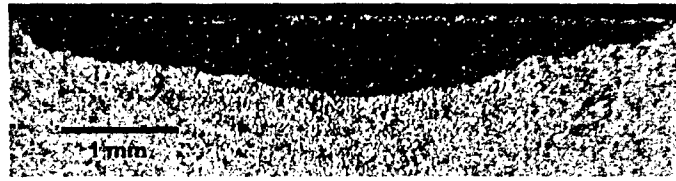
Figure 10 Crack Configuration in an experimental test replicating the engine conditions

The results of these analyses have been confirmed by experimental studies which have found that cracks generated in the front snap radius of samples cut from the parent disk grow preferentially in the circumferential direction. The tests in these studies produced a stress-state in the front snap radius that was similar to, but not fully representative of, the service conditions. The shape of the crack obtained in these test conditions is shown in Figure 10.

Since no in-service cracks have been seen to-date this prediction has not been fully validated. It is intended to carry out full-scale spin pit tests of 4<sup>th</sup> LPC engine disks with implanted flaws in the front snap radius to fully validate these predictions.
